**Third Five-Year Review Report
for
Firestone Tire & Rubber Co. (Albany Plant)
EPA ID GAD990855074**

**Albany
Dougherty County, Georgia**

April 2011

E² Inc.

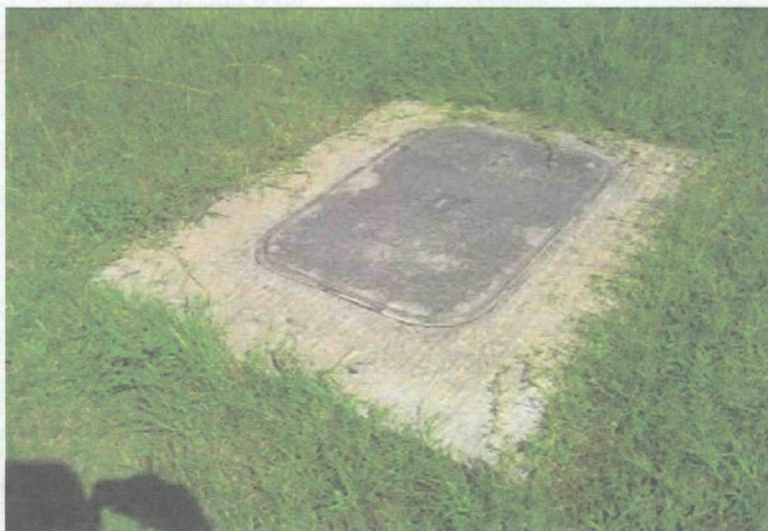
Covered monitoring well.

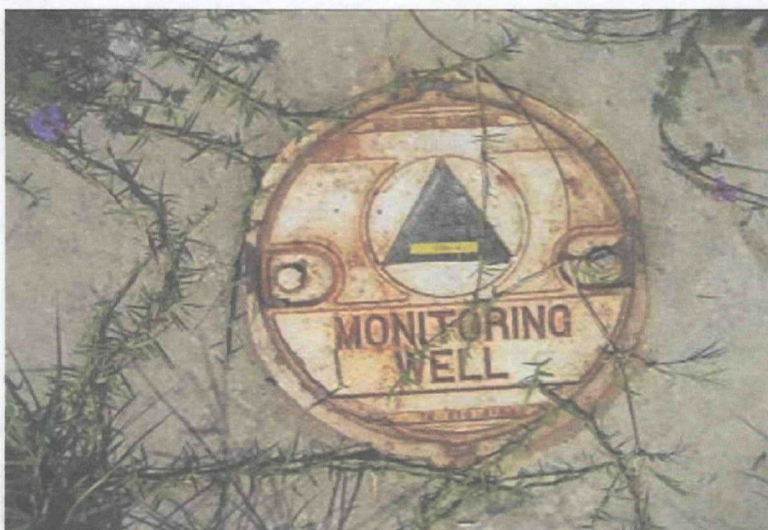
Labeled monitoring well at Site. Notice silicon caps to protect well from rain water.

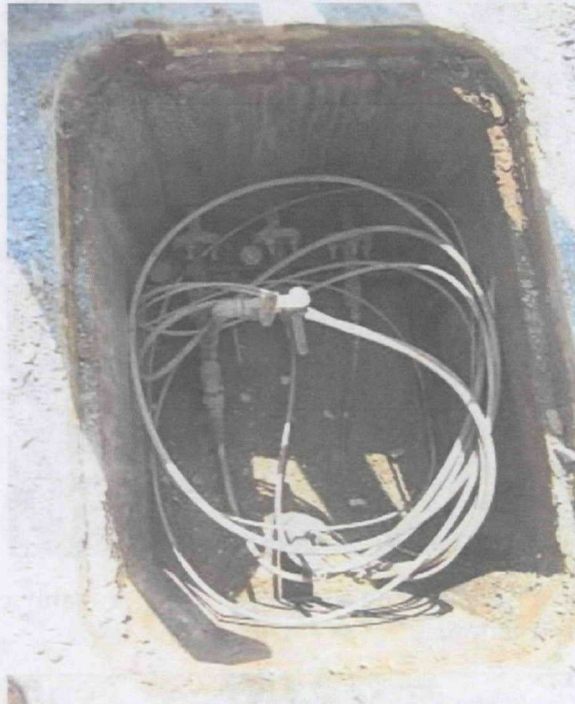
Well opened during inspection showing interior area free of water.

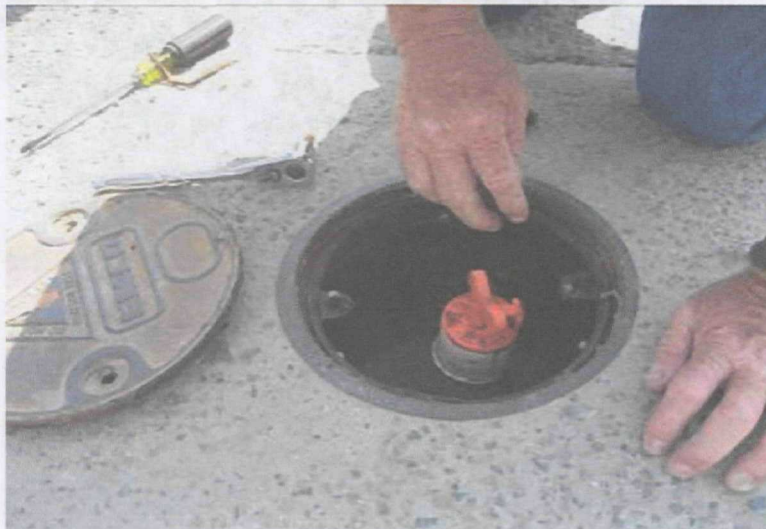
Some ground water wells are exposed to heavy traffic at the Site and have been damaged. Some wells have water inside their access pits and are missing identification labels.

Well opened during inspection showing rain water inside compartment.

Issue	Recommendations/ Follow-Up Actions	Party Responsible	Oversight Agency	Milestone Date	Affects Protectiveness? (Yes or No)	
					Current	Future
Some ground water wells are exposed to heavy traffic at the Site and have been damaged. Some wells have water inside their access pits and are missing identification labels.	Improve O&M by adopting measures to protect and maintain active ground water wells to ensure appropriate performance of the ground water remedial system.	PRP	EPA	01/01/2012	No	No

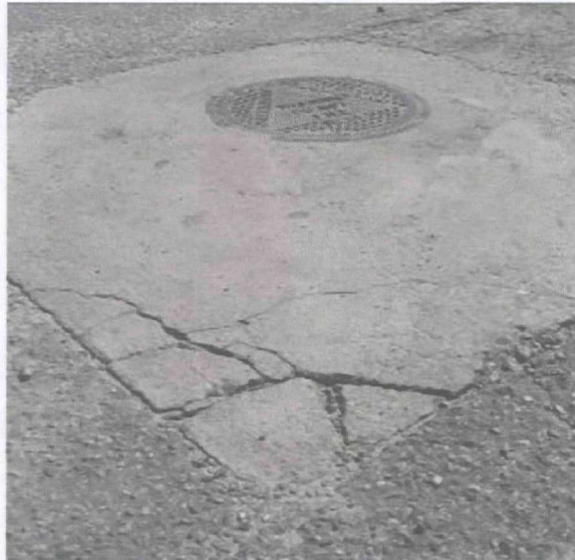
The monitoring equipment, in particular ground water wells, is exposed to heavy traffic of machinery and other equipment due to current activities at the Site. It has been reported during this FYR period that at least one well has been damaged and later repaired. Damage to the monitoring and remediation equipment could delay the progress of ground water remediation at the Site and should be prevented.

Well concrete pad showing a cracked corner probably caused by heavy transportation.

Violations have been reported			<input type="checkbox"/> Yes <input checked="" type="checkbox"/> No <input type="checkbox"/> N/A
Other problems or suggestions: <input type="checkbox"/> Report attached			
Improve care of monitoring wells since they are exposed to damage by operations at Site.

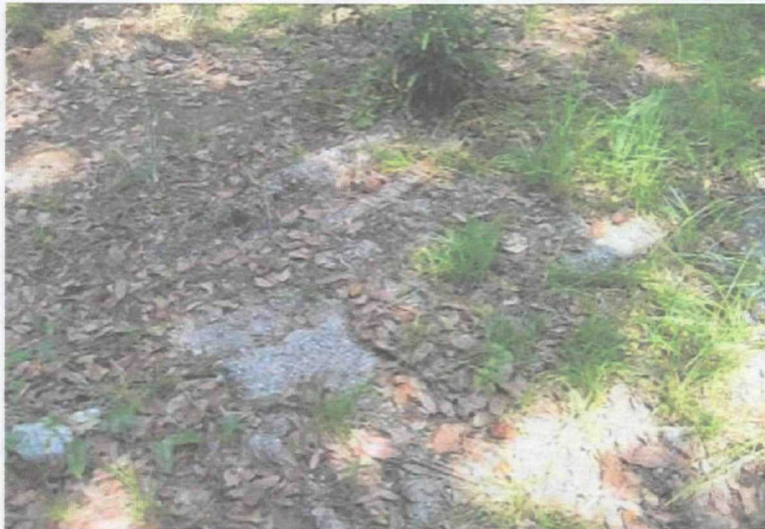
Location of a closed monitoring well in southern section of the Site.

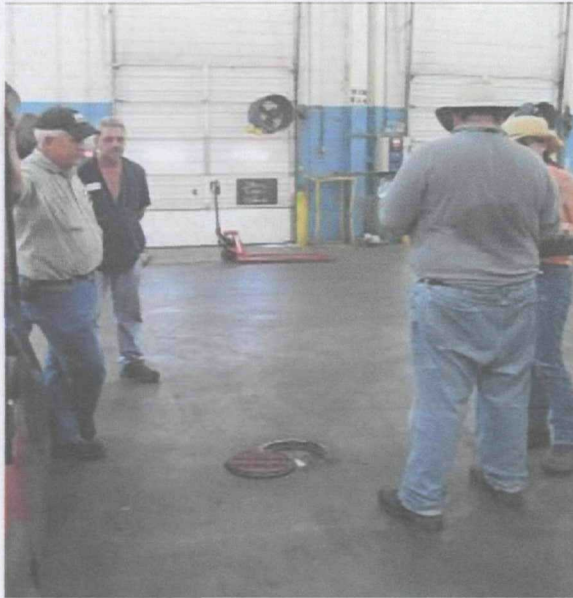
Inspection of monitoring well inside storage area at the Site.

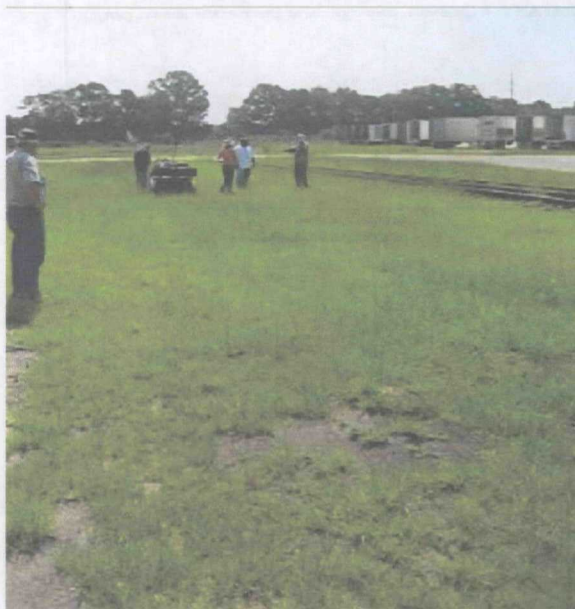
Former location of closed wells near center of the Site.
